May 01, 2008

Re: Ingraham High School – Northwest grove of trees

**subject: Exceptional Tree Review at Ingraham High School**

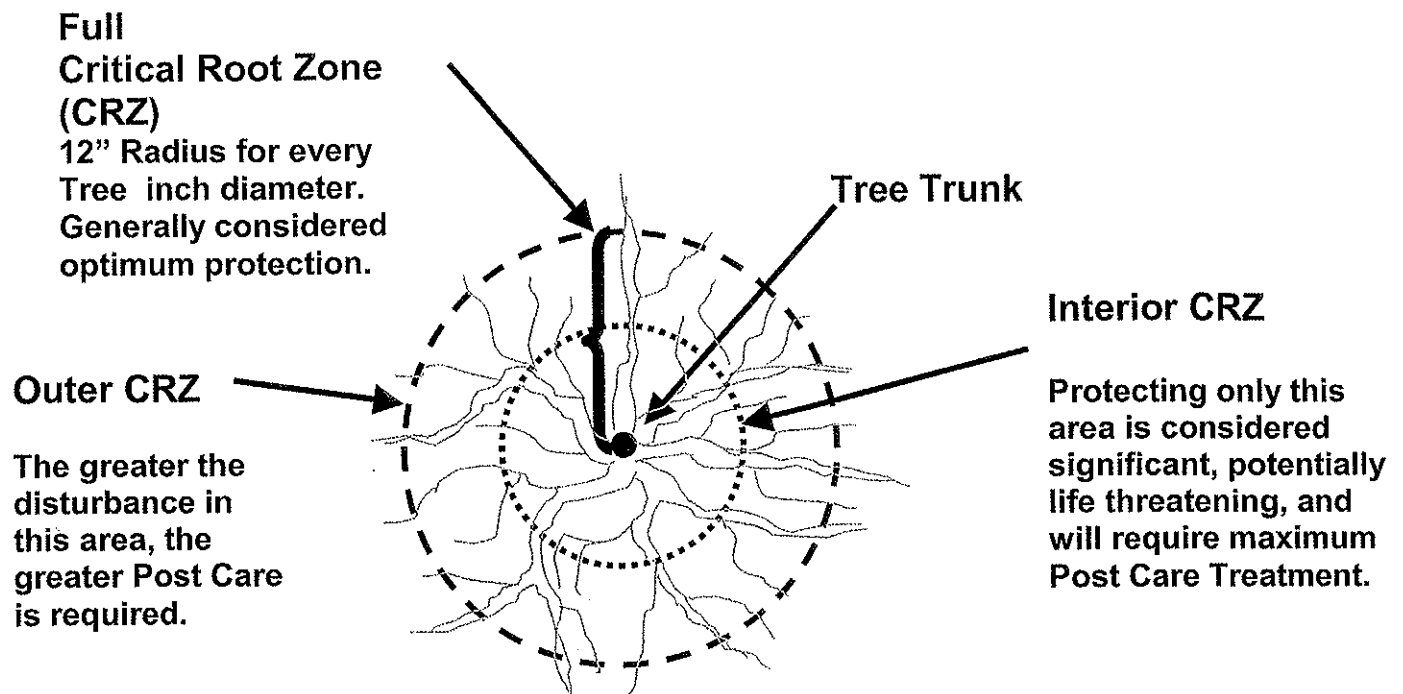
The following report is in response to the current proposed site plan for the Ingraham High School. The proposed building addition is located in the northwest area and will impact the existing grove of trees. Currently there are 133 trees located within this area. 90 of these trees are proposed for removal due to impact to the critical root zone. The critical root zone (CRZ) of a tree is established based on the trees’ trunk diameter. The CRZ is a circular area which has a radius of 12” to every inch of trunk. The CRZ may vary depending on the size of tree, soil, water table, species and other factors.

The critical root zone is a recognized standard within the tree industry for establishing a protection zone and as a general guideline for what trees might survive proposed construction activity. Protecting this entire zone within the outer critical root zone should result in no adverse impact to the tree. It was determined by the design team that 43 of the existing trees could be retained with special provisions provided through construction activity. It is my understanding from review of the site drawings that the design team has carefully considered the impacts to the critical root zone of all remaining 43 trees. Grading and site activities have been kept outside the outer critical root zone for most of the trees. Two trees that are located close to the proposed building, will have special grading and wall construction activities that will impact a small portion of the outer CRZ.

The trees to remain should be individually reviewed after removal of the trees within the construction zone. Remaining trees should be reviewed by a certified arborist for viability and potential to withstand proposed construction activity. Tree protection fences should be installed at the established location of trees identified to remain prior to the start of any construction activity. Regular monitoring of these trees should be performed by a certified arborist on a bi-monthly basis through out the construction process. Monitoring should include review of conformance to established tree protection measures. After construction is complete, each tree should be individually reviewed and assessed for damage and hazard potential. The School District should perform ongoing post-construction maintenance to promote optimal tree vigor. Post construction care should include, but may not be limited to: regular irrigation, bio-stimulants, mycorrhizal inoculations, mulching, and pruning of dead wood.
